Synergistic Exploitation of Geoinformation Methods for Post-earthquake 3D Mapping and Damage Assessment

Abstract This paper presents a methodological framework, which establishes links among the: i. 3D mapping, ii. 3D model creation and iii. damage classification grades of masonry buildings by European Macroseismic Scale-98 and the application of geoinformation methods towards 3D mapping and damage assessment after a catastrophic earthquake event. We explore the synergistic exploitation of a Real Time Kinematics system, terrestrial photogrammetry, Unmanned Aircraft Systems and terrestrial laser scanner for collecting accurate and high-resolution geospatial information. The proposed workflow was applied at the catastrophic earthquake of June 12th, 2017 on the traditional settlement of Vrisa on the island of Lesbos, Greece. The Structure from Motion method has been applied on the

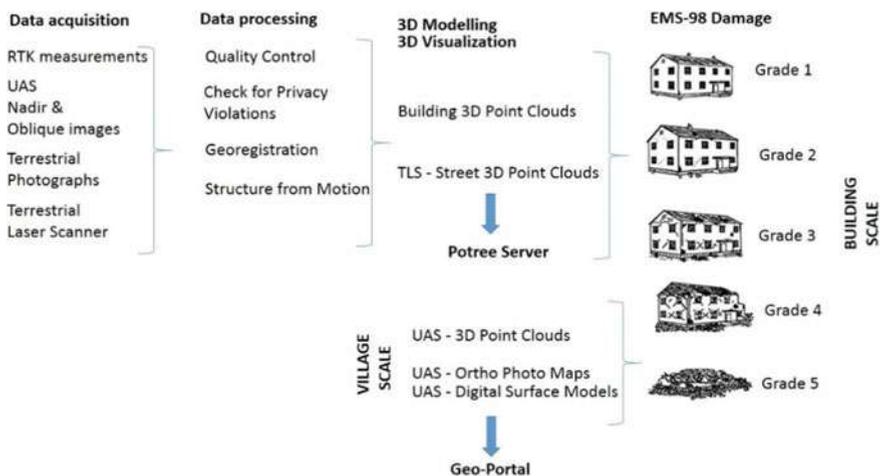
Fig. 1 Flowchart of the methodological framework for post-earthquake 3D mapping and building damage assessment of at two scales: i. village and ii. building

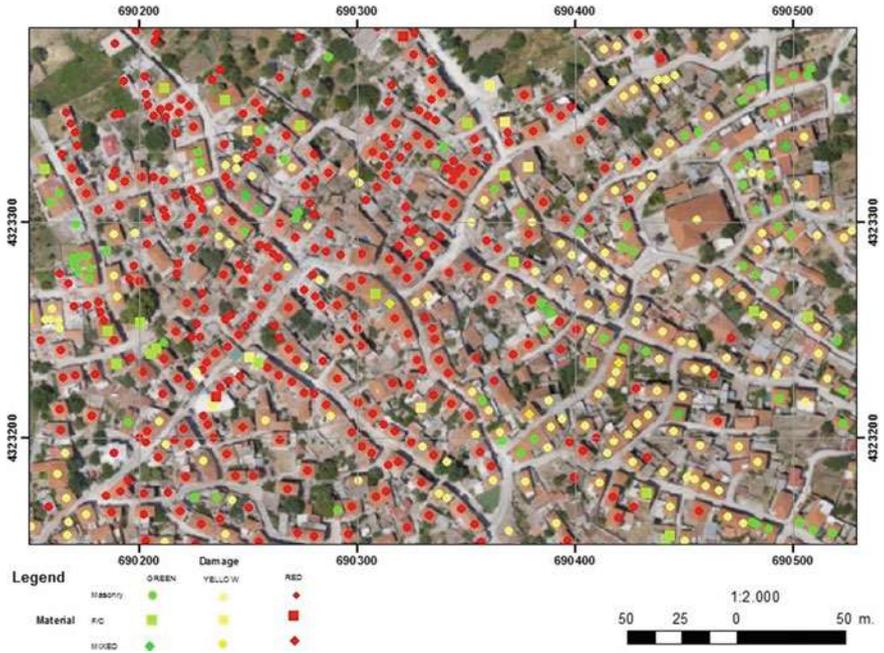
Fig. 2 Map presenting the distribution of first-degree inspections by the Greek ERO in combination with buildings' material

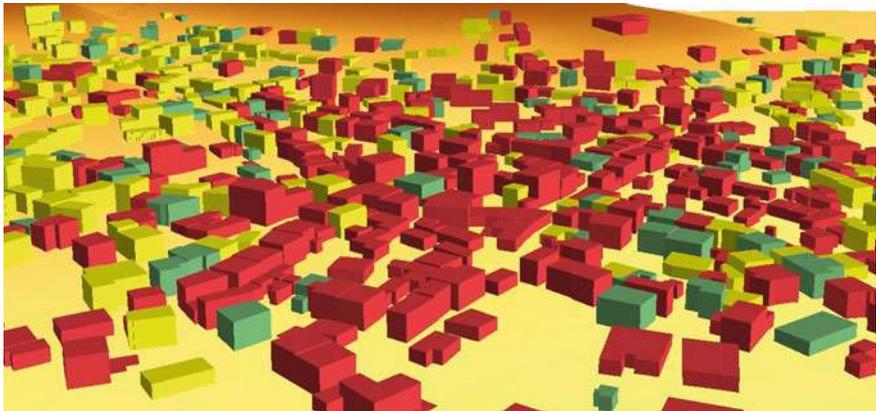
Fig. 3 3D visualization presenting the distribution of first-degree inspections by the Greek ERO in combination with buildings height. The buildings were distinguished into the following three categories: i. “Green—Safe for Use”, ii. “Yellow—Unsafe for Use” and iii. “Red—Dangerous for Use” according to the Earthquake Planning and Protection Organization guidelines

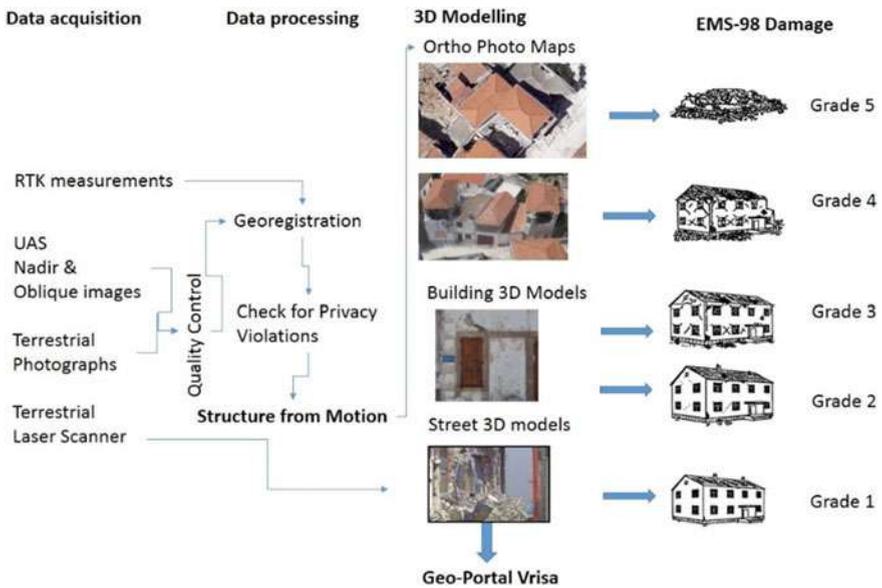
Fig. 4 Flow chart of the application of 3D mapping methods on Vrisa settlement after the catastrophic Lesvos earthquake

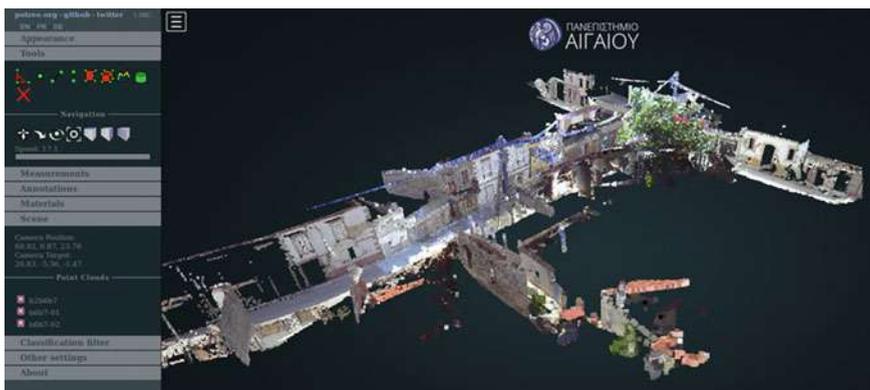
Fig. 5 Web-application (Potree) of the “Vrisa project” showing three interconnected 3D-scans in the main square of the village

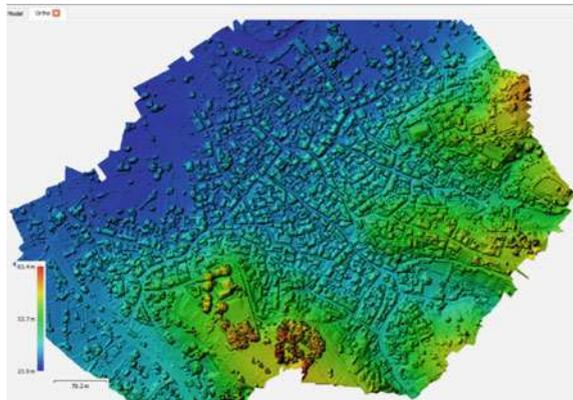
Fig. 6 Digital surface model map provided by the 13th June 2017 campaign, at a scale of 1:4.000 proved to be useful for the estimation of the collapsed and partially collapsed buildings

By processing the 229 nadir, high-resolution aerial images obtained the day after the earthquake, from an altitude of 160 m., an orthophoto map, a digital surface model (Fig. 7) and a 3D point cloud has been produced and proved to be very efficient in ‘early damage assessment’ stage. The results, required only a few hours of processing due to the small number of photos, capturing all the important information and providing a clear view of the heavily damaged areas of the Vriza settlement, as well as those that were not essentially affected.

Additionally, the DSM of Vrisa settlement (Fig. 6) derived by the processing of the 229 nadir UAS images provides a very effective mean to measure building heights after the earthquake, giving an estimation of their volume, and the possible extent of their total or partial collapse. Moreover, 3D visualization of the 3D point cloud gives the opportunity to visually explore the entirely collapsed buildings due to their smaller heights compared with the surrounding buildings (Fig. 7).

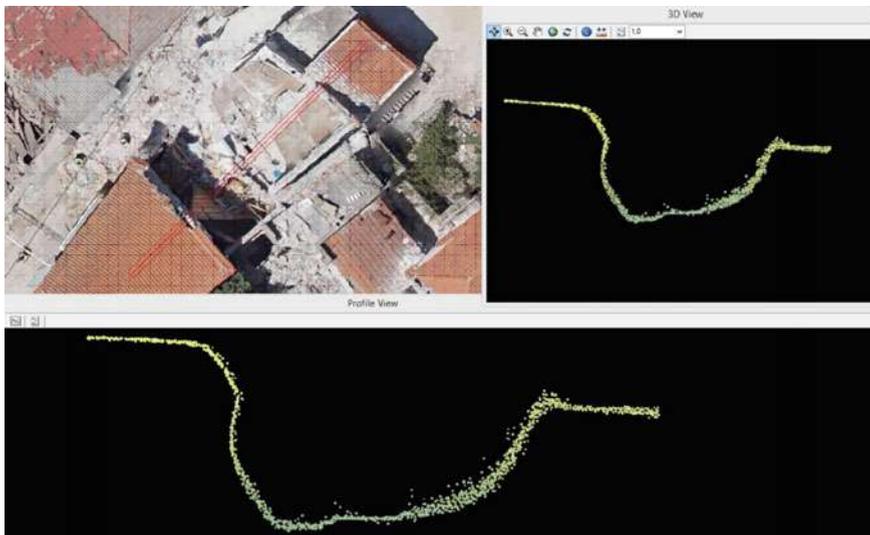
Fig. 7 3D Profile views of the 3D PointCloud (13/06/2017). Collapsed buildings can be clearly distinguished due to their smaller heights

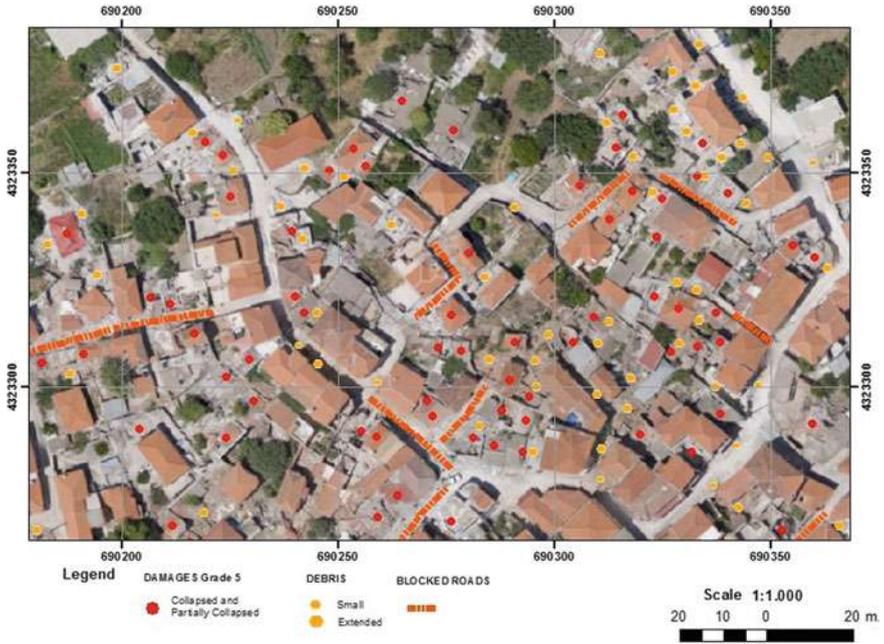
Fig. 8 Orthophoto map of 13th June 2017 at a scale of 1:1.000 showing the NW part of Vriza settlement which concentrates a large number of building of grade damages 5 e.g. partial and total collapse of buildings, the blocked roads and the areas with debris

In addition, UAS high-resolution image acquisition, from medium altitudes i.e. 160 m, provides in a very short time a concise view of the earthquake affected areas. Furthermore, by visual interpretation very accurate and reliable information concerning the severity of an earthquake can be mapped, giving a very precise assessment for buildings having very heavy structural damages (grade 5), which can be taken into consideration for initiating effective emergency response and recovery actions (Fig. 8).

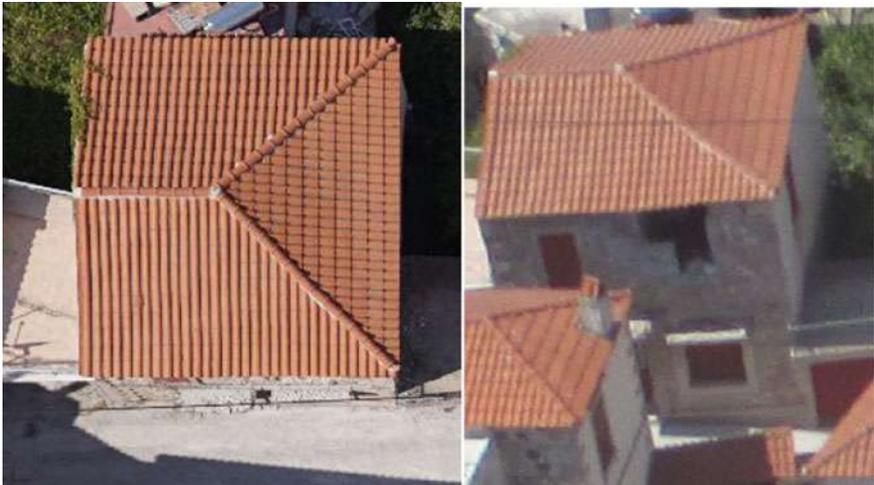
Fig. 9 Part of a nadir (left) and oblique (right) image acquired on 25th June 2017. A serious failure of the top part of a wall is captured only on the oblique image (right)

The UAS data acquisition campaign that took place on July 25th, 2017, was implemented using an innovative Malteser cross configuration 4-camera rig. In this campaign, 1.044 nadir and 4.084 oblique high-resolution images (Fig. 9) were

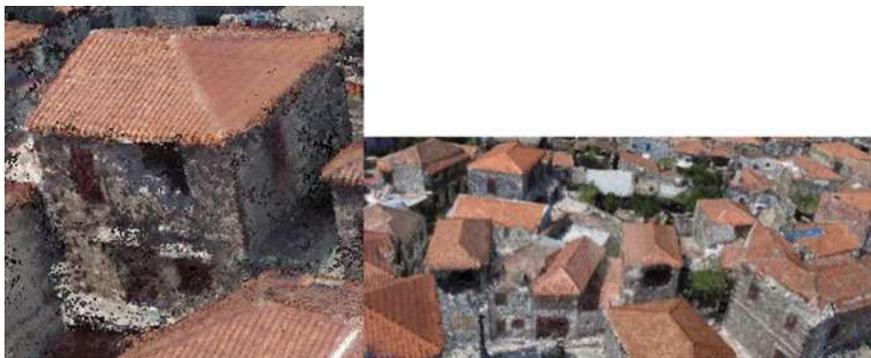
Fig. 10 Parts of the 3D point cloud derived by nadir and oblique images acquired on 25th June 2017, where building damages of grade 4 are clearly identifiable

acquired, from an altitude of 65 m and processed with the SfM method. The derivatives were the sparse and dense 3D point clouds (Fig. 10), a DSM, a 3D model (mesh), and an orthophoto map (Fig. 11).

Based on the EMS-98 damage classification, on the specific orthophoto map and 3D point cloud, building damages of grade 4-very heavy damage (heavy structural damage, very heavy non-structural damage) serious failure of walls; partial structural failure of roofs and floors, can be visually identified. Building damages of grades 1, 2 and 3 are not identifiable. These results highlight the importance of applying suitable UAS configurations and flight planning characteristics, e.g. low altitude, more than one oblique cameras on board, to achieve more detailed and reliable 3D information (Fig. 10).

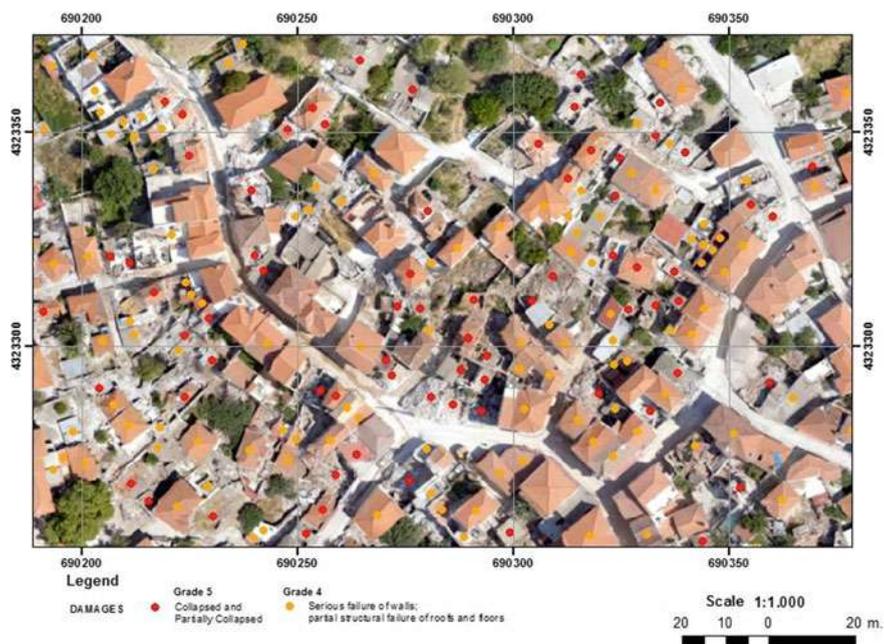
Fig. 11 Orthophoto map of 25th June 2017 at a scale of 1:1.000 showing the NW part of Vrisa settlement which concentrates a large number of building with damages of grades 4 and 5

The produced orthophoto map, having a spatial resolution of 3 cm, presents clearly: i. totally or/and partially collapsed buildings, ii. roof damages (chimney collapse, roof detachment, etc.) and iii. debris close to the buildings that are reliable indicators of wall detachments and wall collapse. As such, visual interpretation of the orthophoto map can assist damage assessment especially for damages of grades 4 and 5.

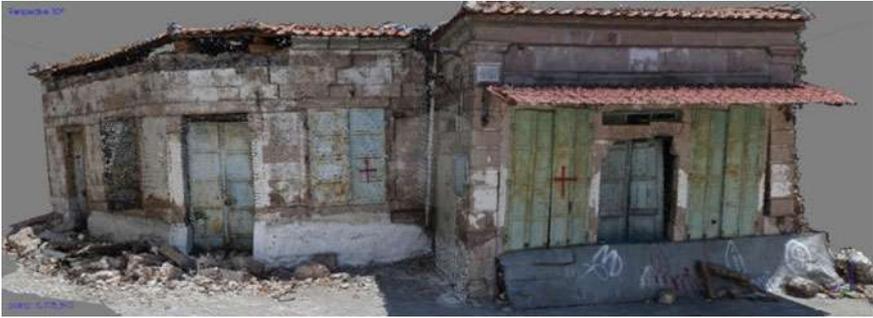
Fig. 12 Part of a 3D model produced by terrestrial photogrammetry

All the 240 3D Point Clouds (Fig. 12) and the 140 Point Clouds of the 3D laser scanner (Fig. 13), created by TP and TLS respectively, provide the most important 3D information for assessing building damages of: i. grade 1: negligible to slight damages of the buildings, ii. grade 2: moderate damages, e.g. cracks in many walls, detachment of small pieces of places from the walls and partial collapse of chimneys, and iii. grade 3: substantial to heavy damages e.g. large and extensive cracking of all masonry load-bearing walls, detachment of large pieces of plaster in all load-bearing walls, dislocation and fall of roof tiles, detachment of the roof from the rest of the structure and fall of gables. Their very high resolution and accuracy permit the identification of hair-line cracks in walls, fall of small pieces of plaster only, falls of loose stones from upper parts of buildings and measure their characteristics (length and width of cracks, volumes of debris from falls, etc.).

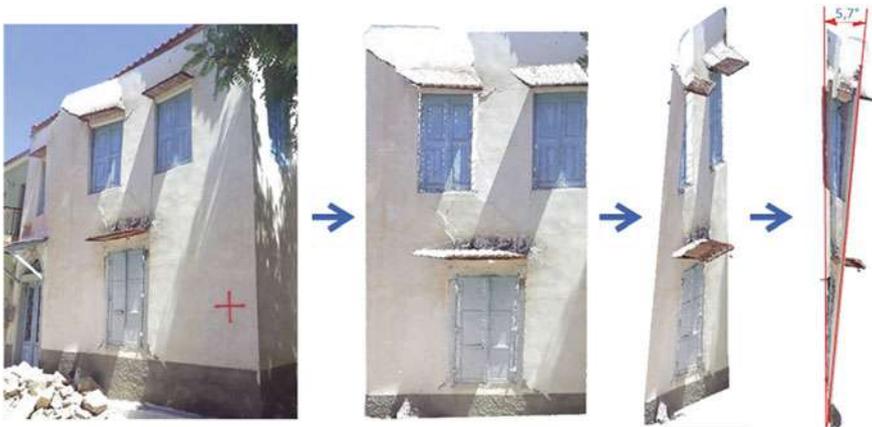
Fig. 13 Measuring the deformation of wall from a TLS point cloud

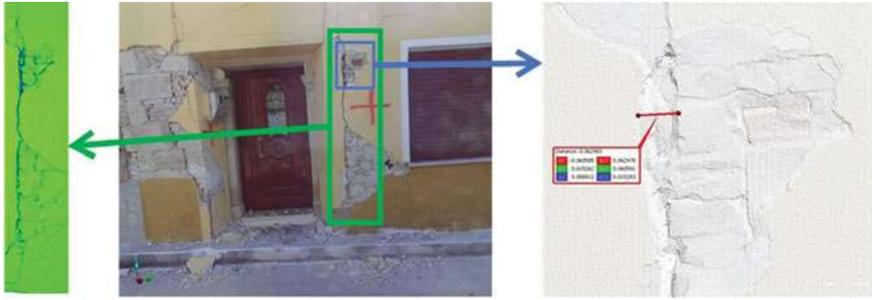
Fig. 14 Finding cracks on buildings and measuring in detail the dimension of cracks from a TLS point cloud

The ability to perform measurements is a very critical issue as post-earthquake situation is not suitable for that (Fig. 14). Especially during the first days after the disaster, it is impossible to get close enough to the buildings. Also, measurements on the upper parts of the buildings cannot be performed because it is impossible to access these parts of the buildings.

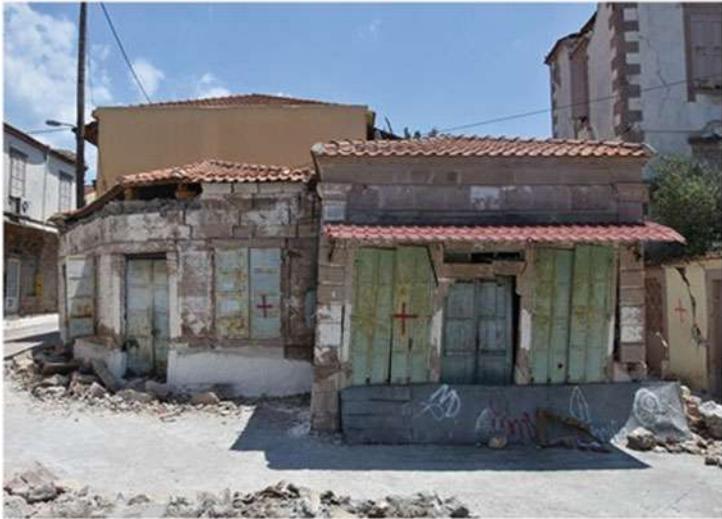
Fig. 15 An example from the first page of the proposed documentation of building damage assessment. It contains all the important information concerning the building such as: geographical coordinates, type of structure, grade of damage and all the technical characteristic of the 3D point cloud produced by terrestrial photogrammetry

- i. the first page presents all the important information concerning the building such as geographical position, type of structure, grade of damage and all the technical characteristic of the 3D point cloud produced by terrestrial photogrammetry (Fig. 15),
- ii. the second page contains the 3D point cloud derived by terrestrial photogrammetry of the building, and with the 3D measurement tool it is possible to access the model and perform measurements of distances, angles and volumes (Fig. 16),

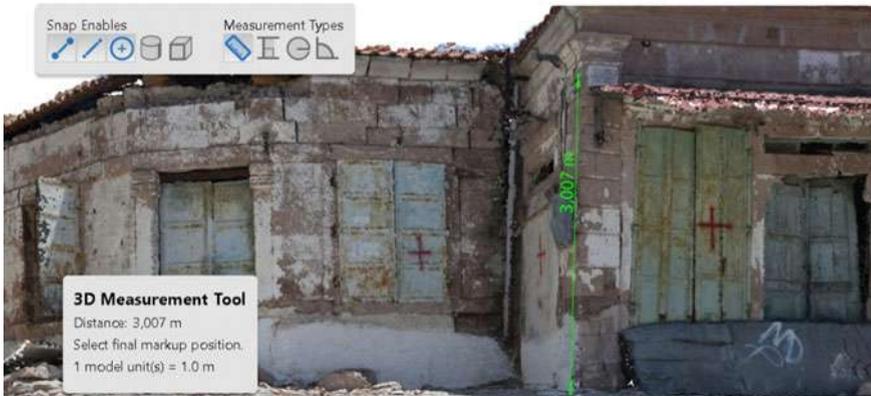
Fig. 16 An example from the second page of the proposed documentation of building damage assessment which contains the 3D point cloud obtained by the high-resolution terrestrial photos. The 3D measuring tool permits the accurate measurement of distances, angles and volumes

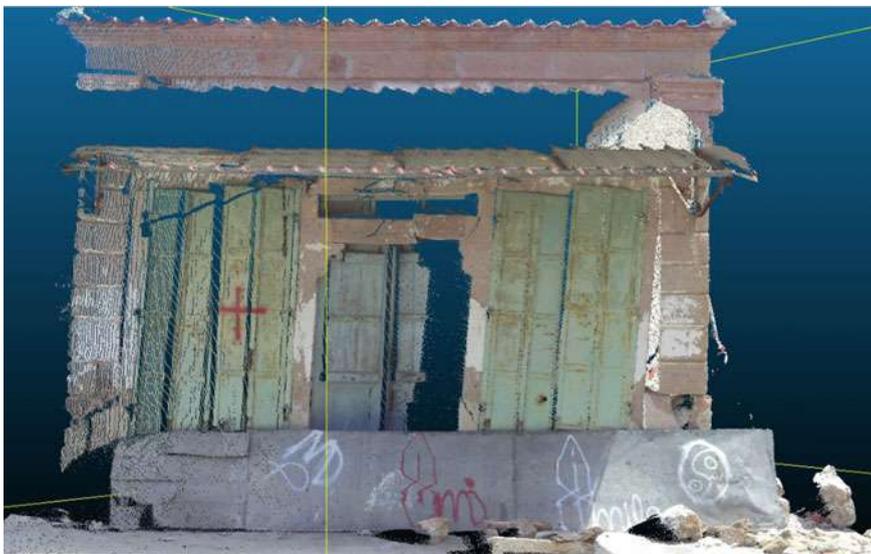
Fig. 17 An example from the third page of the proposed documentation of building damage assessment, which contains the 3D point cloud derived by TLS. The 3D measuring tool permits the accurate measurement of distances, angles and volumes

- iii. the third page contains the 3D point cloud derived by TLS, and with the 3D measurement tool it is possible to access the model and perform measurements of distances, angles and volumes (Fig. 17),

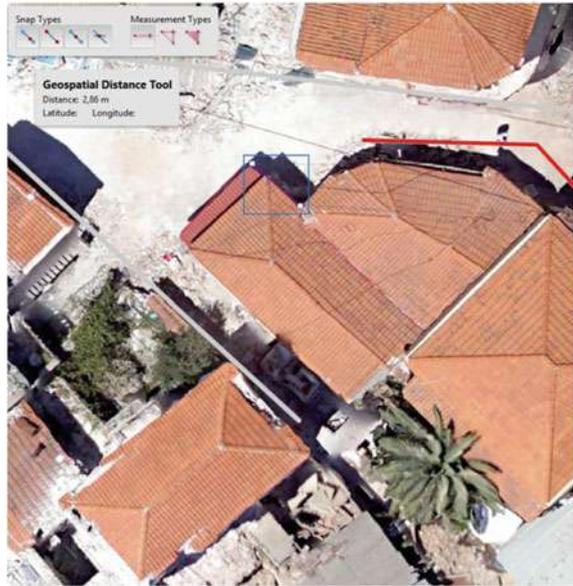
Fig. 18 An example from the fourth page of the proposed documentation of building damage assessment, which contains the part of the high resolution orthophoto map presenting the damaged building. The measuring tool permits the accurate measurement of distances and surfaces

- iv. finally, the fourth page contains the appropriate part of the high resolution orthophoto map presenting the building and/or buildings, and with the 2D measurement tool it is possible to access the map and perform measurements of distances and areas (Fig. 18).

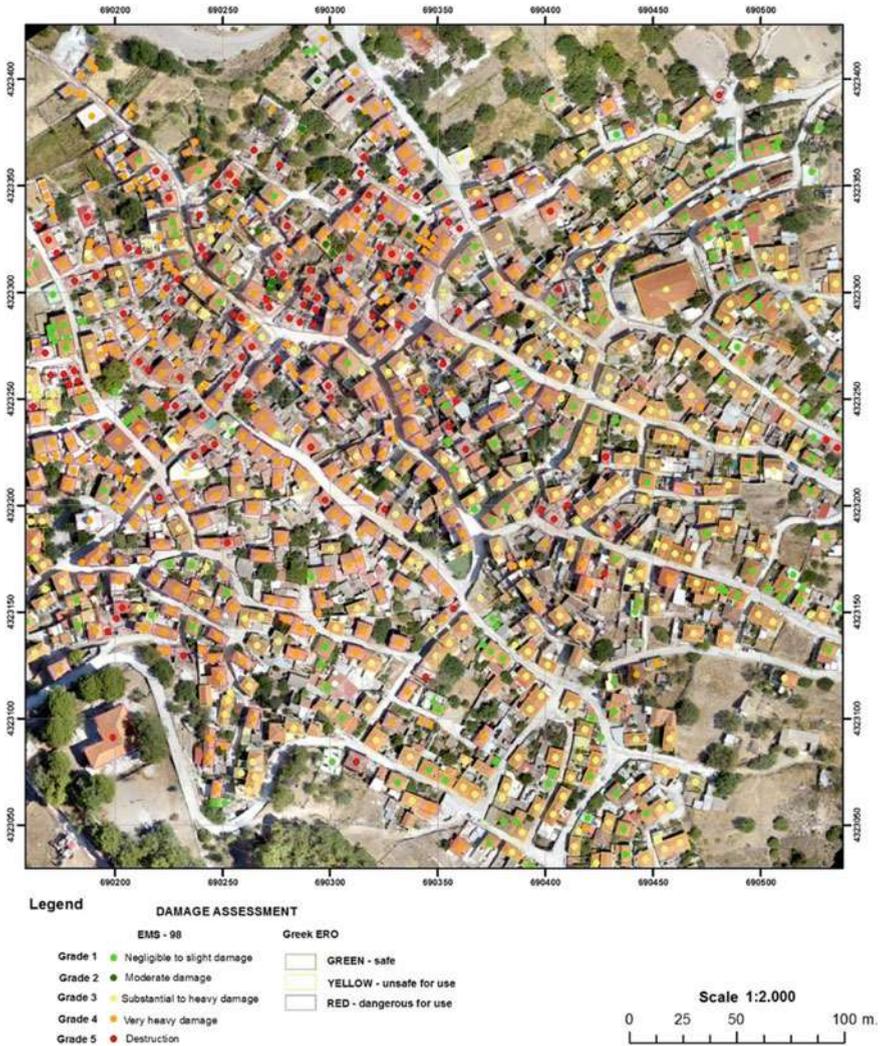
Fig. 19 Orthophoto map of 25th June 2017 at a scale of 1:2.000 presenting Vrisa settlement with damage assessment results by: i. first inspection by Greek ERO and ii. by the use of the 3D Point Clouds produced during the present study

During the present study, a building damage assessment has been performed based on the results obtained by the followed methodology (Fig. 19). It is worthy to mention that the current damage assessment results should not be considered as fully reliable because all datasets involved cover only the external parts of the buildings. The damage evidence that can be captured from the orthophoto maps and 3D Point clouds could not consider sufficient to infer the actual damage state of the building as it requires damages to the internal building elements (e.g., columns and beams) that cannot be directly defined from the images and 3D point clouds. Despite the fact that this information is limited to the external part of the buildings, the images can provide useful information about the external condition of the masonry buildings, showing damages and providing a first important piece of information for structural engineers. Taking into consideration all the above, the results obtained by the damage assessment are summarized in Table 2.

The comparison between these results with the equivalent assessment derived by the Greek ERO shows that: i. the majority (70%) of the GREEN-buildings has been evaluated having damages of grade-1 while only 12% having damages of grade-2,

ii. the majority (78%) of the YELLOW-buildings has been evaluated having damages of grade-3 while only 10% of grade-4 and finally iii. the majority (64%) of the RED-buildings has been evaluated having damages of grade-4 and only 23% of grade-5 (see Table 3).
