# SYNERGISTIC EXPLOITATION OF GEOINFORMATION METHODS FOR POST-EARTHQUAKE 3D MAPPING OF VRISA TRADITIONAL SETTLEMENT, LESVOS ISLAND, GREECE

Conference Paper · March 2018

**KEY WORDS:** Post-earthquake 3D mapping, Lesvos earthquake, UAV, Laser Scanning, SfM method

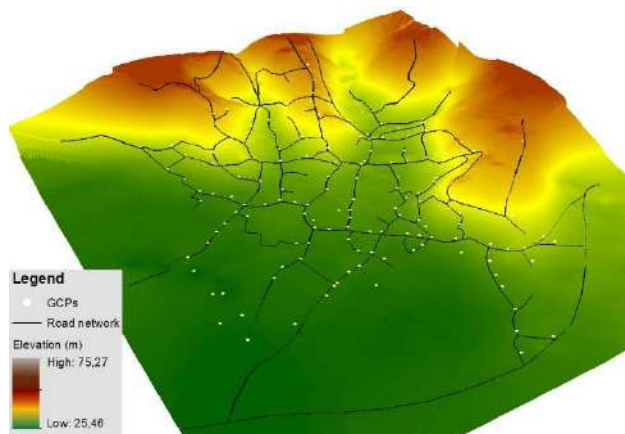
Figure 2. Digital Elevation Model of the study area, derived by kriging interpolation of the 157 RTK elevation measurements.

1. Two Base Stations (BS) were established within the village of Vriza, depending on the base of the greek National Trigonometric Network (NTN) located at the top of the hill named Korona, SW of the settlement of Vriza having coordinates X = 689641.55 Y = 4322030.77 and Altitude = 135.98. Due to the morphology of the settlement, as it is developed on three hills and two flat relatively low altitude surfaces (Figure 2), the two BSs were placed on the

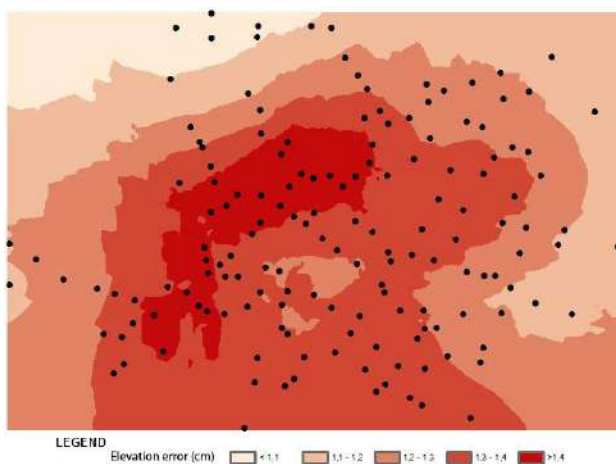
Figure 3. Spatial distribution of the elevation error by the 157 RTK measurements.

One hundred fifty seven (157) GCPs were placed within the Vrisa settlement, having very high accuracy in three dimensions (X, Y, Z), with an RTK rover, the base of which was placed at the one of the two base points, depending on the area where the GCPs were placed, to achieve better reception and a greater number of satellites, with an average horizontal error of 0.8 cm and an average elevation error of 1.3 cm (Figure 3). The GCPs were

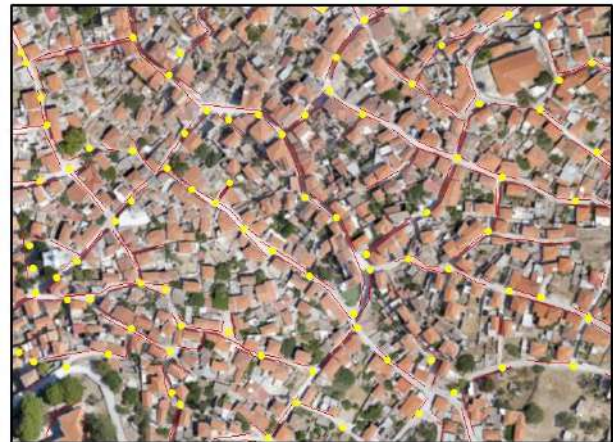
Figure 4. The 240 sections of the terrestrial photograph and the 140 TLS positions campaigns.

More specifically, the Vrisa settlement was divided into 238 road sections where each section included not more than five buildings (Figure 4) and about 20,000 photos were taken covering all the buildings of Vrisa village, taking into serious consideration that the post-earthquake activity was in progress and many aftershocks with magnitude 4 – 5 were frequently occurring.

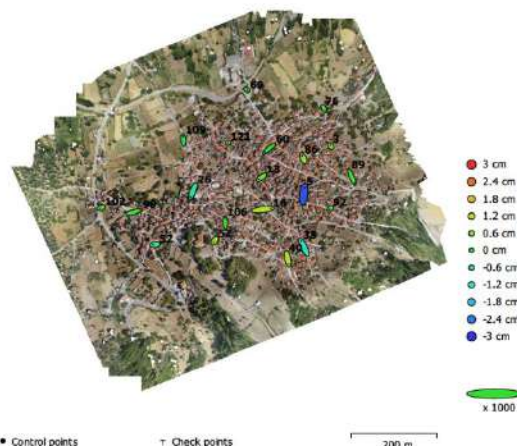
Figure 5. GCP locations and error estimates.

GCP locations and error estimates are depicted in Figure 5. The estimated GCP locations are marked with a dot and Z error is represented by a colored ellipse. Furthermore, X, Y errors are represented by elliptical shapes where the size of the ellipse for the major and minor axes represents the magnitude of X and Y errors respectively. From the geo-registration accuracy achieved, one can conclude that the precision of the geoinformation produced is of satisfactory accuracy for earthquake damage assessment.

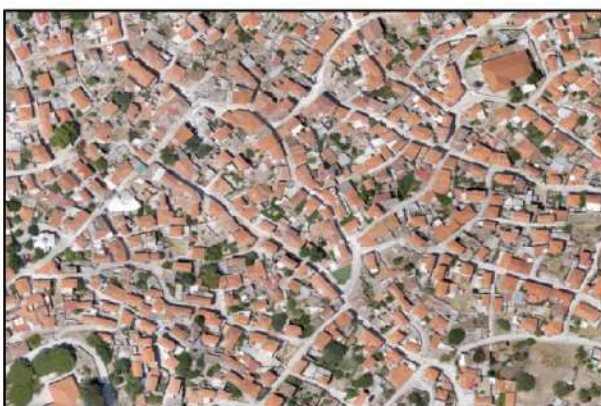
Figure 5. Orthophoto map of 13<sup>th</sup> June 2017, scale: 1:4.000 illustrating damages of grade 5 e.g. partial and total collapse of buildings.

The Orthophoto map (Figures 5, 6) and DSM (Figure 7) produced by processing the 229 UAS aerial high-resolution images, which were obtained from flights at 160 m altitude, proved to be very efficient in ‘early damage assessment’. Both products, obtained after few hours of processing due to a few photos, capture all the important information and give a clear view of the most damaged areas of the Vrisa settlement, as well as those that were not essentially affected. Collapsed and nearly collapsed buildings can be visually recognized, streets closed by collapsed building stone walls can be clearly seen, and even destroyed chimneys can easily identified. Based on the EMS-98 (Grünthal, 1998) damage classification on the specific results damages of: i.) Grade 5: destruction e.g. partial and total collapse of buildings and, ii.) Grade 4: very heavy damages e.g. heavy structural failure of roofs and floors can be visually identified giving a quick and accurate assessment of the earthquake devastation. Additionally, the DSM of Vrisa settlement (Figure 7) provides the most effective means to measure building heights and surfaces after the earthquake, giving an estimation of their volume, and the possible extent of their total or partial collapse.

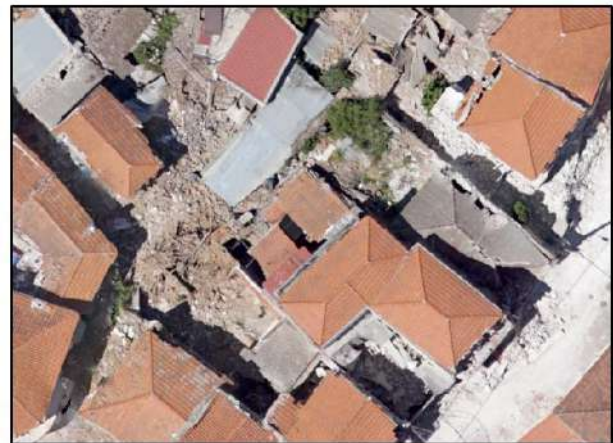
Figure 6. Part of the 13<sup>th</sup> June 2017 orthophoto map at a scale of 1:500 with damages of grade 4 e.g. heavy structural failure of roofs and floors.

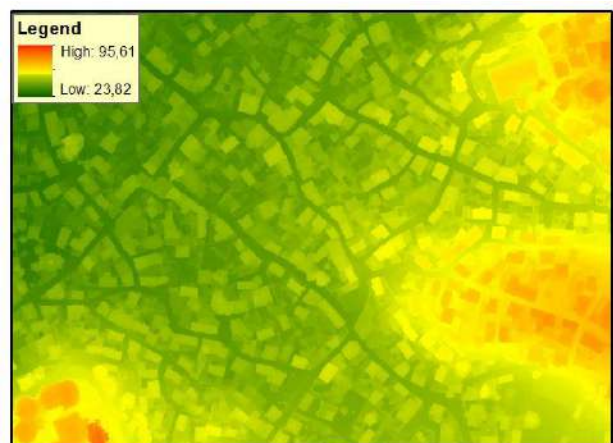
Figure 7. DSM for the 13<sup>th</sup> of June 2017, scale 1:4.000

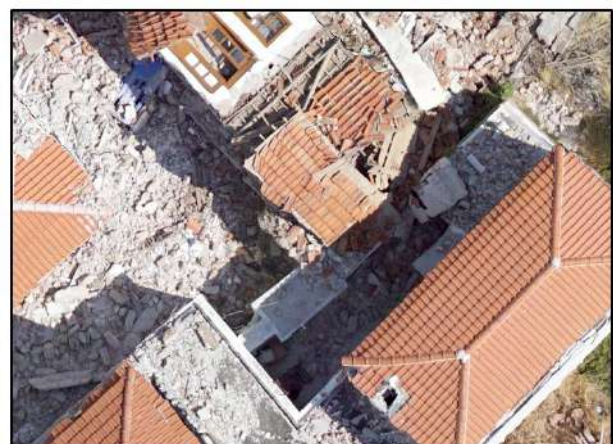
Figure 8. Part of the 25<sup>th</sup> July 2017 orthophoto map at a scale of 1:200 which clearly shows damages of grade 3, e.g. dislocation and fall of roof tiles, detachment of the roof from the rest of the structure and fall of gables.

The Orthophoto map (Figures 8, 9 and 10) and DSM, produced by processing the 1050 nadir and oblique UAS aerial high-resolution images which flew at 65m altitude, proved to be very effective for creating a 3D model at village scale (date: 25 July 2017). This 3D model (Figure 10) captures many of the building facades and as such it provides accurate information concerning the grade of damage occurred to buildings.

Based on the EMS-98 (Grünthal, 1998) damage classification, on the specific orthophoto map, building damages, can be visually identified i.e. Grade 2: moderate damages e.g. cracks in many walls, detachment of small pieces of places from the walls and partial collapse of chimneys, and Grade 3: substantial to heavy damages e.g. large and extensive cracking of all masonry load-bearing walls, detachment of large pieces of plaster in all load-bearing walls, dislocation and fall of roof tiles, detachment of the roof from the rest of the structure and fall of gables. The results highlight the importance of applying suitable flight planning characteristics e.g. low altitude, more than one oblique cameras on board, in order to achieve more detailed and reliable 3D information (Figures 8 and 9).

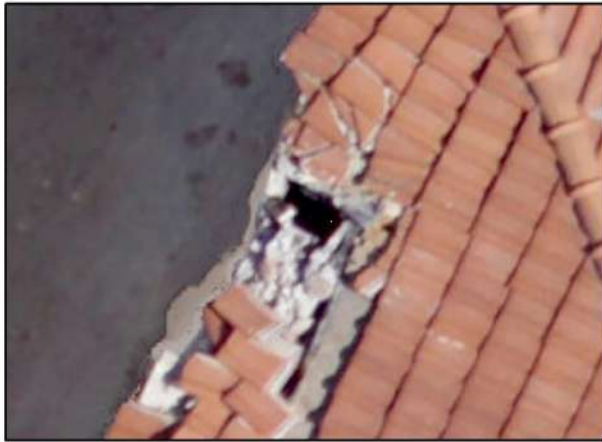
Figure 9. Part of the 25<sup>th</sup> July 2017 orthophoto map at a scale of 1:40 which clearly shows damages of grade 2 on the top of the buildings, e.g. collapse of a chimney.

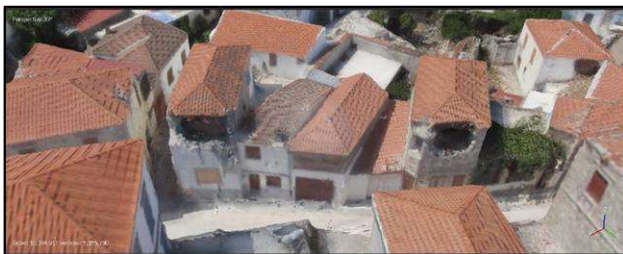
Figure 10. Part of the 25<sup>th</sup> July 2017 3D model produced by nadir and oblique UAS-derived high-resolution images.

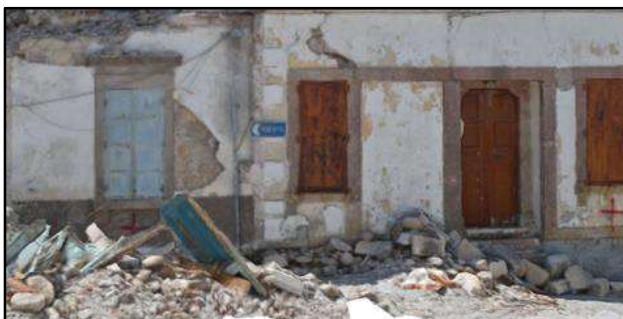
Figure 11. Part of a 3D model produced by terrestrial photogrammetry.

All the 240 3D models (Figure 11) and the 140 point clouds of the 3D laser scanner (Figure 12), created by terrestrial photogrammetry and TLS respectively, provide the most

important 3D information for assessing damages of Grade 1: negligible to slight damages of the buildings. Their very high resolution and accuracy permit identifying hair-line cracks in walls, fall of small pieces of plaster only, falls of loose stones from upper parts of buildings.

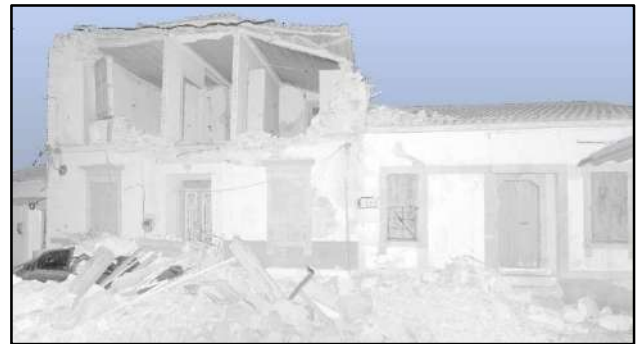
Figure 12. Part of a TLS 3D model with intensity values.
